# Bird Barrier<sup>®</sup> Optical Gel<sup>™</sup>

## CASE STUDY » Pub

## CASE STUDY » Hotel

## CASE STUDY » Shopping Center

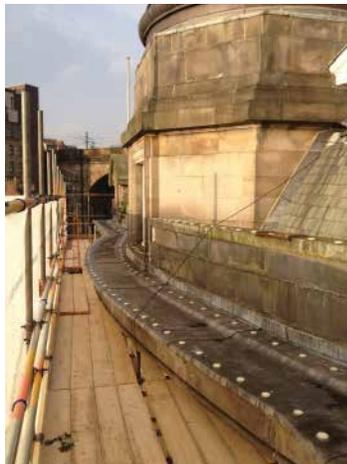
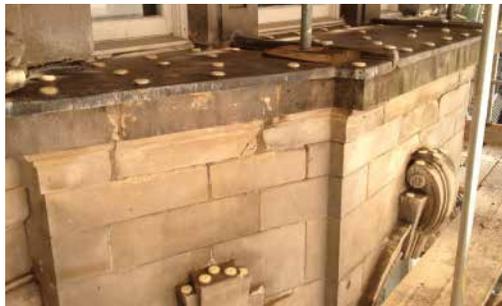
The entire façade was pressure-washed and all nests were removed. To prevent day roosting, the cornice above the fourth floor was treated with two rows of dishes of Optical Gel at 12 in. centers (left); while the deep ledges in front of the three bay windows on either side of the façade at the fourth floor were treated with three rows of dishes at 12 in. centers.

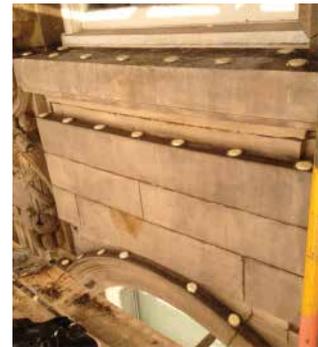
At the third floor, nests were removed from the curved lintels above the central windows. Optical Gel dishes were placed at 6 in. centers

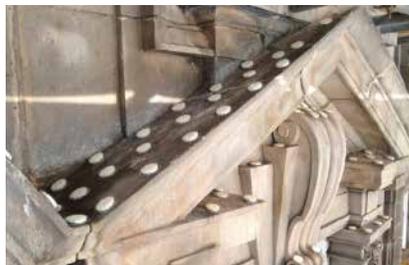
At the second floor, all nests were removed from below the curved lintel above the central window, from below the inverted V-shaped lintels on either side and from the architectural features to left and right. All these surfaces were treated with dishes of Optical Gel at 6 in centers to prevent nesting.

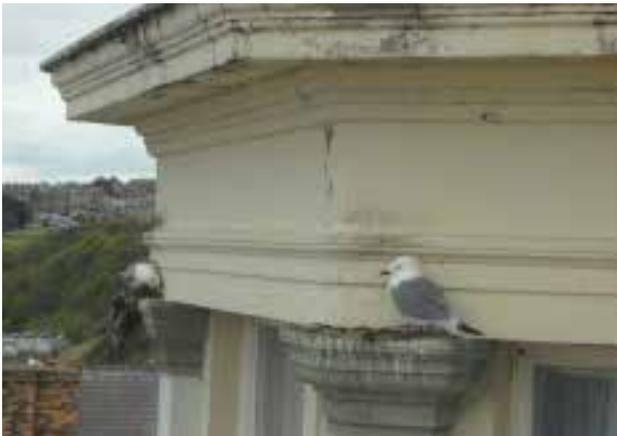
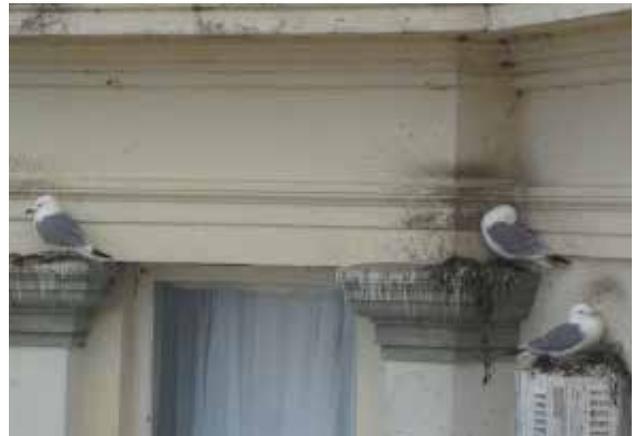
Optical Gel dishes applied to the façade above the main entrance are invisible from below

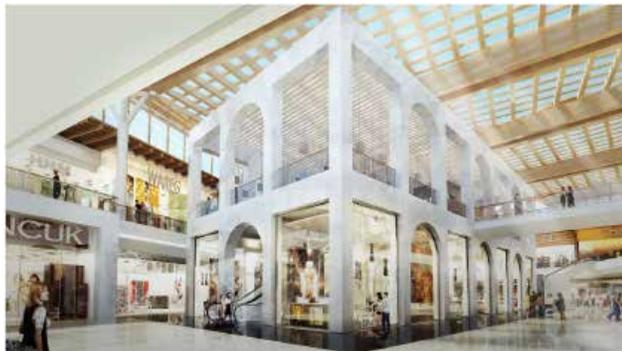
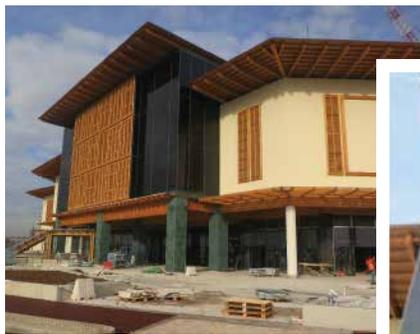
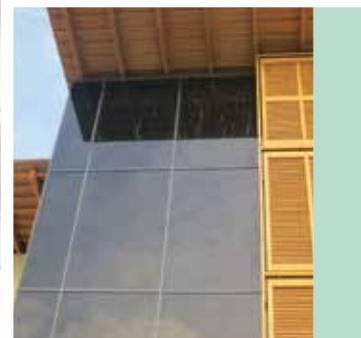
Even before construction was completed pigeons started to roost in sheltered parts of the building. Pigeons roosting below the roof were creating an unsightly mess on the glass façades

The owners of the shopping center decided that prevention was better than cure. So, in December 2015 approximately 9,000 dishes of Optical Gel were fixed to all the sheltered parts of the structure. (The covers were subsequently removed from the dishes.)
