Encapsulation & Dehumidification Case Study

Location: Maryville, Tennessee
Age of Home: 25 Years
Size of Crawlspace: 1,000 Sq. Ft.
Homeowner: Danny Burns
Installer: Thompson Waterproofing & Allied Pest Control

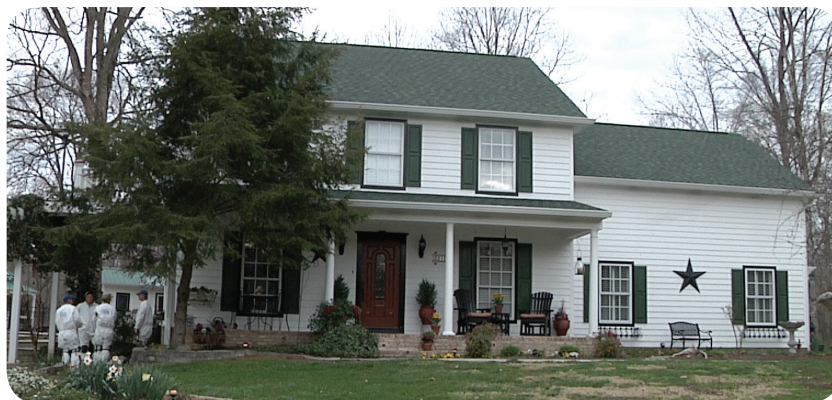
While having some ductwork repairs done on his home, Danny Burns noticed there was lots of black mildew and standing water in his crawlspace. "This had me very nervous," says Burns. "I have always been leery of termites but the mold had me very concerned. I plan on living in my home the rest of my life, so I want to make sure it is not going to rot down on me."

Prior to encapsulating the crawlspace the floor joists and walls were cleaned in order to remediate the existing fungus and mold. The wet fiberglass insulation and existing clear floor plastic was removed from the space. In order to help stop the infiltration of outside humid air into the space, all openings in the sidewalls, including vents and doors leading to the exterior were sealed.

Due to excess water intrusion around the foundation from the outside a French drain with a sump pump was installed to help mitigate standing water in the crawlspace.

The foundation and floor were lined with a crawlspace felt underlay to protect the vapor barrier from sharp objects like broken concrete or sharp stones. A reinforced polyethylene vapor barrier was used to prevent moisture from seeping into the crawlspace. Grade 12 Mil (or higher) is recommended for crawlspaces, as it is specifically designed to effectively block moisture and withstand the ground's natural alkaline qualities, which quickly break down in cheaper recycled materials, leaving the home unprotected. Proper installation of the vapor barrier is essential to controlling moisture, and as a result, minimizing the pest and fungi that thrive in a damp crawlspace.

Lastly, a Santa-Fe Advance2 dehumidifier was installed with a condensate pump to remove any excess humidity. This will ensure the structure of the house remains durable, the indoor air quality in the rest of the home is healthy, and the crawlspace remains inhospitable for fungi, mold, dust mites, wood destroying insects, and other pests.
